**NASA Technical Memorandum 81432**

**APPLICATION OF COMPOSITE  
MATERIALS TO TURBOFAN  
ENGINE FAN EXIT GUIDE VANES**

**G. T. Smith  
Lewis Research Center  
Cleveland, Ohio**

**Prepared for the  
Thirty-fifth Annual Conference of the  
Reinforced Plastics/Composites Institute  
sponsored by the Society of Plastics Industries  
New Orleans, Louisiana, February 4-8, 1980**

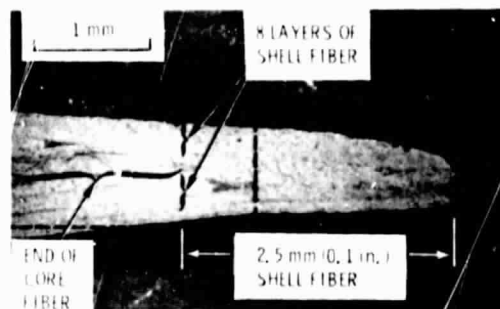
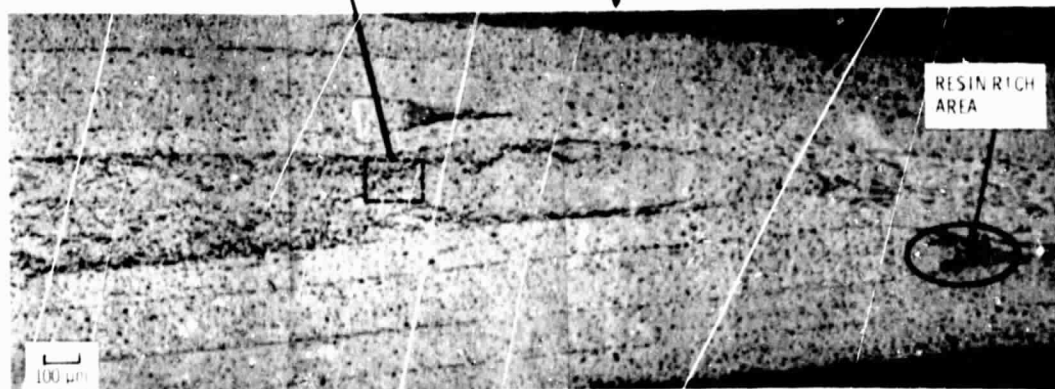
Figure 3. - Fabrication defects in early JT9D fan exit guide vanes.

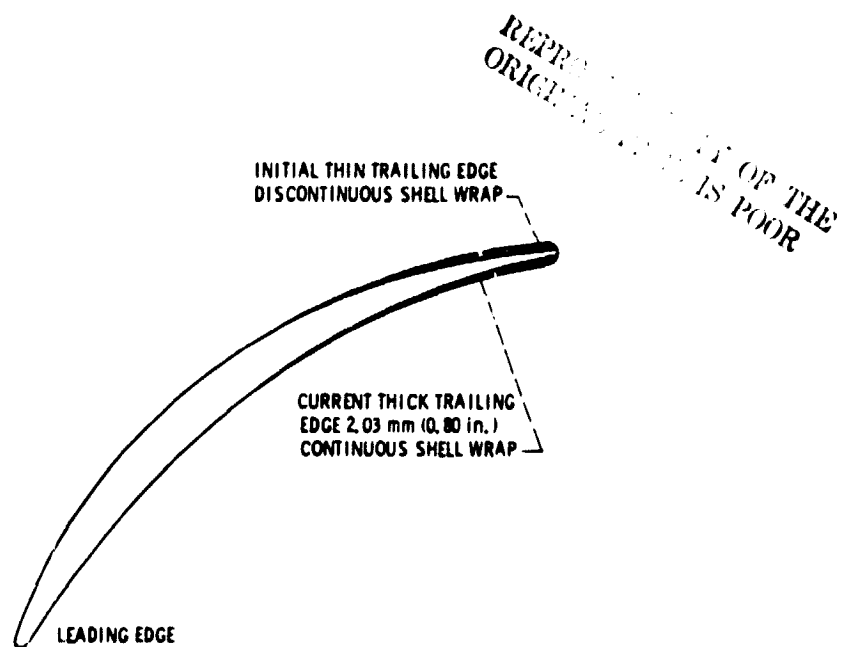
Figure 4. - Initial and current JT9D composite vane cross section.

The failure mode experienced during the -70 model engine operations indicated that a reduction in the vane first bending moment deflections coupled with improvements in the physical characteristics of the composite materials were needed to attain adequate operational durability. Changes in both the vane design parameters and in the fiber treatment were made. The design parameter changes included both a change in the external vane contour and a change in the shell lay-up patterns. Figure 4 illustrates the revised trailing edge contour.

The trailing edge thickness was increased and the lay-up pattern modified to provide additional trailing edge stiffness. The modified lay-up pattern is compared with the original -70 model pattern in figure 5. The original thin trailing edge vane was characterized by termination of all shell plys in the trailing edge region. The revised design featured a trailing edge wrap around for the four outer plys resulting in a more continuous ply structure in this critical region of the vane.

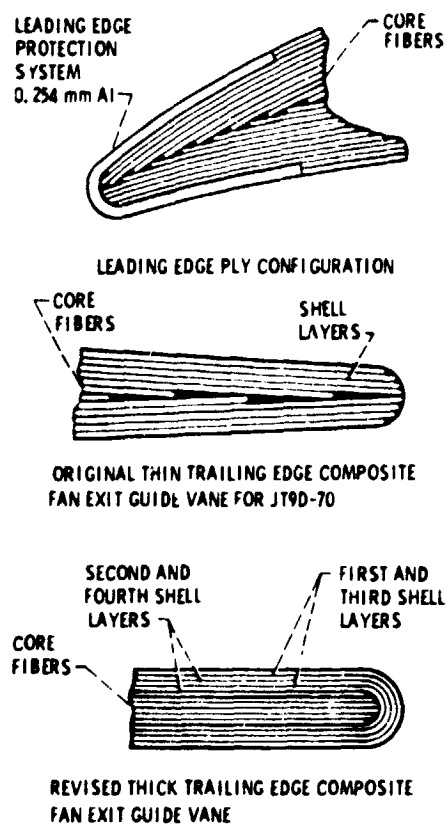
Figure 5. - Comparison of vane ply configurations.

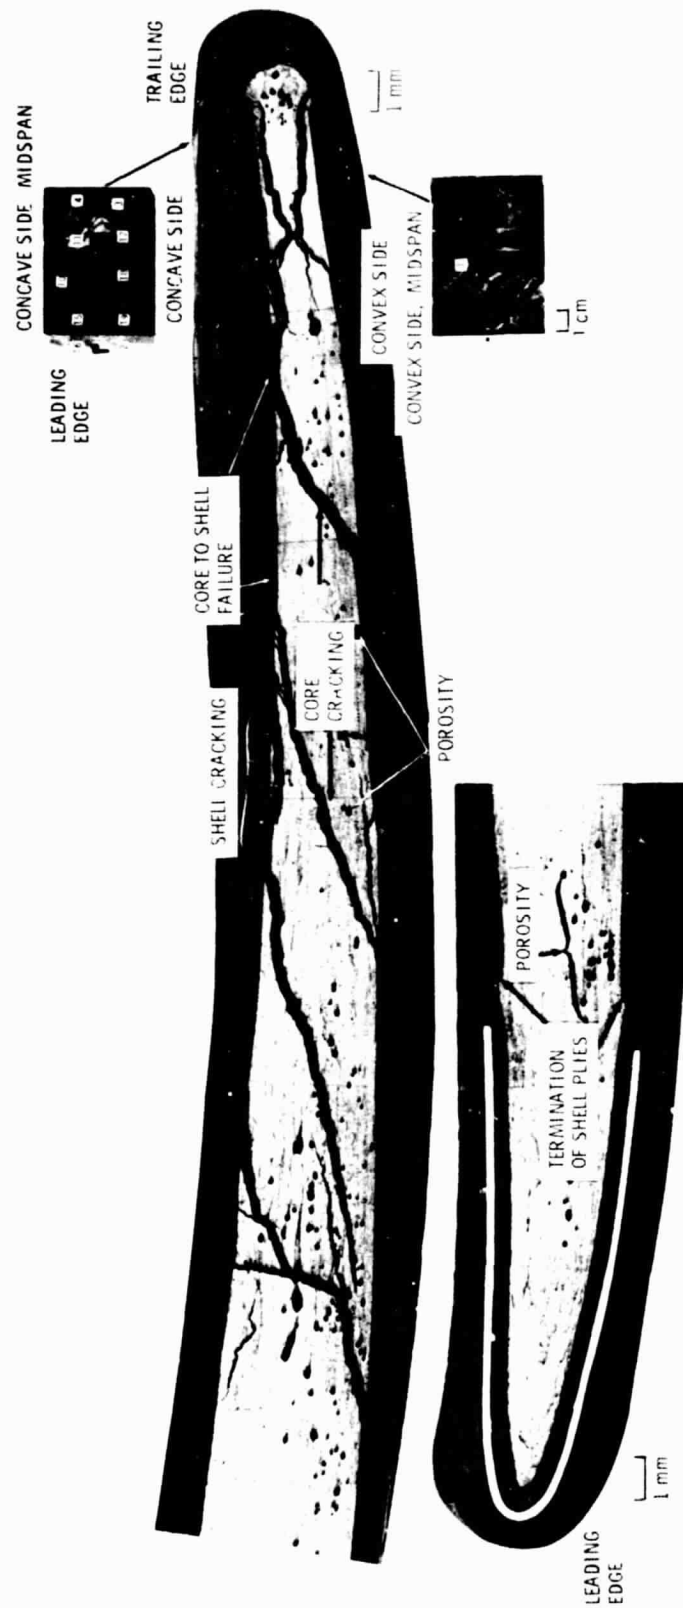
The two fiberglass shell vanes exhibited different failure modes than the all-graphite shell vanes. The highest modulus shell vanes, fabricated by TRW, failed transverse to the span at the vane attachment location. One vane of that group which had the lowest torsional stiffness, failed by a combination of

transverse core cracking at the trailing edge and radial cracking parallel to the trailing edge. Figure 14 presents a photomicrograph of the vane cross section which clearly shows the core cracking and core to shell delamination failures developed during this test. The two small inserts above and below the trailing edge section show the external appearance of the vane at the cross section location. The three stress whitened areas on the convex surface of the vane appear to correspond to the three cracks extending through the core in the photomicrograph.

Figure 14. - Photomicrograph of hybrid glass shell-graphite/epoxy core fan exit guide vane fatigue failure.
